# Manhole Inspection Summary

Manhole # S19MM\_018MH

Insp Date: **7/3/07 1:08 PM**

**Location** Address: **2258 ELGIN AVE**

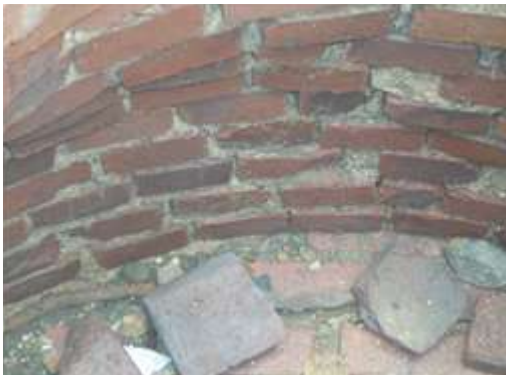
Defect 3

Condition: ☐ Sound ☒ **Cracked** ☐ Root Intrusion ☐ Loose Brick ☐ Deteriorated

CRACKED BARREL

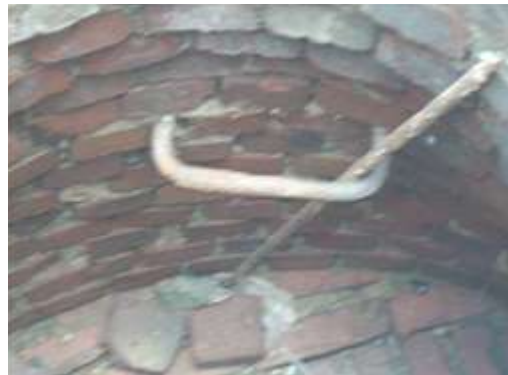
Defect 2

**Steps** Count: **1** Missing: **0** ☒ **Corroded**

CORRODED STEP

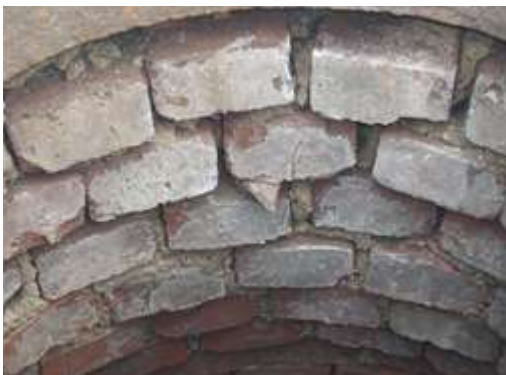
Defect 1

Condition: ☐ Sound ☐ Cracked ☐ Root Intrusion ☒ **Loose Brick** ☐ Deteriorated

LOOSE CORBEL BRICKS

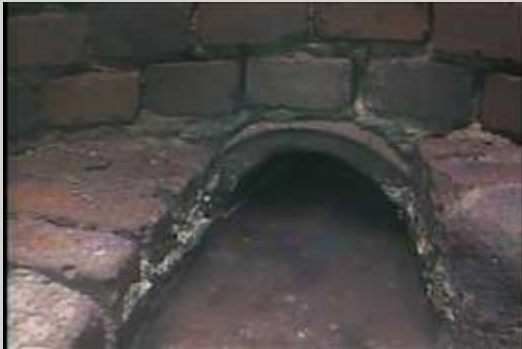
12 O'Clock Outflow

Pipe Height: **8.4** (in.) Rod and Bar (Angled)  
Pipe Material: **Clay** ☐ Pipe Lined  
Invert Depth: **5.60** (ft.) Flow Characteristics: **Slow**  
Deposits: ☐ None ☐ Mud ☐ Sludge ☒ **Debris** ☐ Grease  
Silt Depth: **3** (in.) Deposits Extent: **Light**  
Infiltration: **None** Pipe Seal Cond: **Sound**
